The investigation on the cause of the sinking revealed that the hull of ROKS Cheonan was split by a strong non-contact underwater explosion. The propulsion device(the conclusive evidence) recovered from the seabed indicated that the underwater explosion was caused by a torpedo. Based on these results, this section focuses on estimating the performance of the torpedo(charge size) and the point(depth and location) of the explosion. The US and UK team estimated the charge weight and location with their own expert methods in support of the objective, and in basis of the US and the UK estimation, the ROK team carried out a simulation analysis.

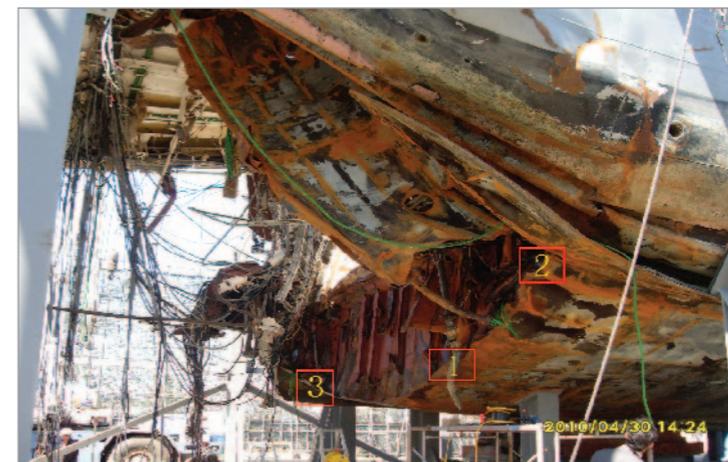
<Figure III-5-6> Sample collection locations at fractured surface

As shown in <Figure III-5-6>, samples of approximately 15cm x 15cm size were collected from three locations at the breakplane of the stern. All the collected samples were identified to be shear and brittle fractures, and revealed no signs of ductile¹¹⁾ or fatigue fracture. Sample #2 shows shear fracture patterns, sample #3 displays a typical brittle fracture, and sample #1 presents a mixture of the two fractures. Also it was confirmed that the patterns showed only shear fracture between sample locations #1 and #2 and only brittle fracture between sample locations #1 and #3.

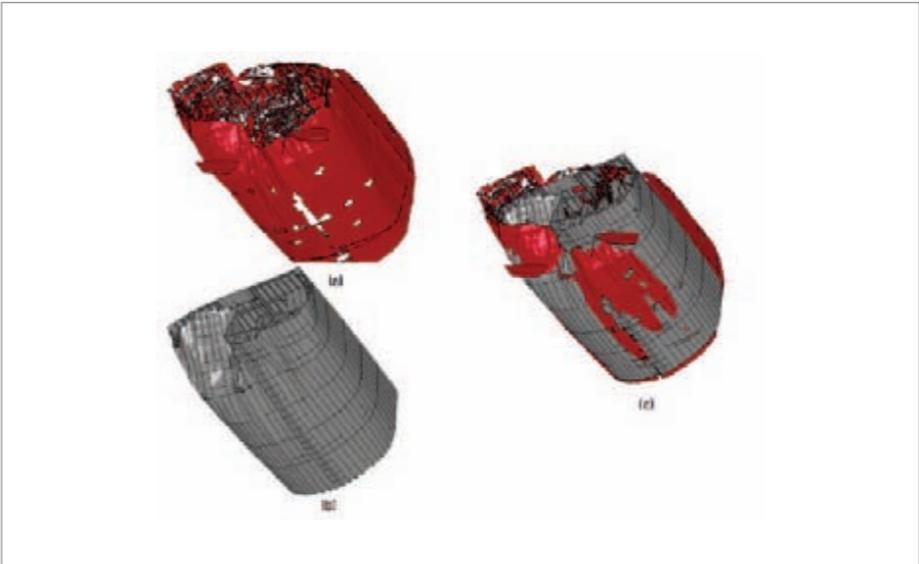
〈Figure III-6-23〉 ~ 〈Figure III-6-28〉 illustrate the comparison between modelled damage result and the damages actually measured from 3D laser scanning image of ROKS Cheonan. Sub-caption (a) indicates the actual damage, (b) indicates the estimated damage results by the model, and (c) is the overlap of (a) and (b). As seen in these sub-captions, the modelled damage and the actual damages appear fairly similar.

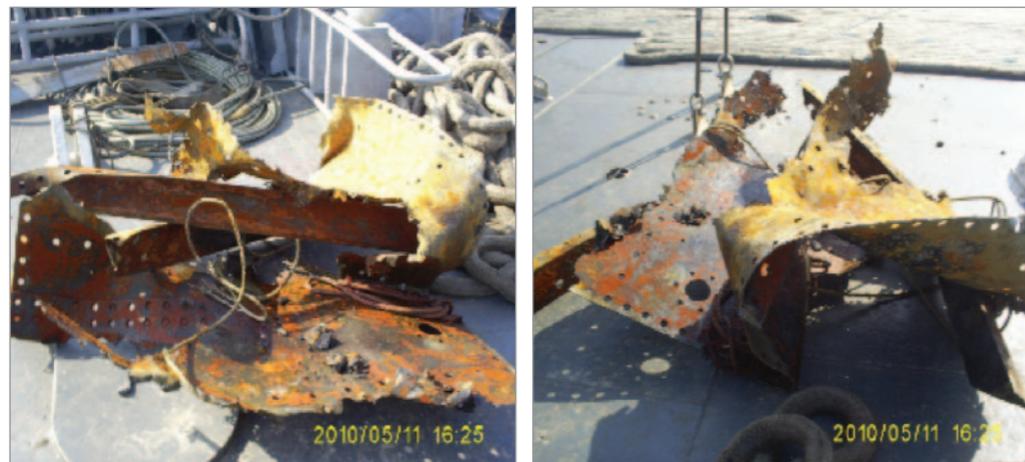
〈Figure III-7-5〉 Metal structure found near unknown sunken vessel

The unknown sunken vessel found in the sinking site is not depicted on the charts. The type of the vessel and the time of its sinking were unknown, and Navy Search and Rescue Group divers conducted investigation on the vessel several times. Acoustic image from Side Scan Sonar found that the vessel had the shape of a merchant vessel (steering gear room in the stern and multiple columns in the middle deck), and many rivetings of the metal structure recovered from near the unknown sunken vessel support the high likelihood that it was a merchant vessel which sunk scores of years ago.

Given the water depth of the location of the unknown sunken vessel (47m), the height of the unknown sunken vessel (10m), and the draft of ROKS Cheonan (2.88m), it was confirmed that the unknown sunken vessel would not have impacted the safety of ROKS Cheo-

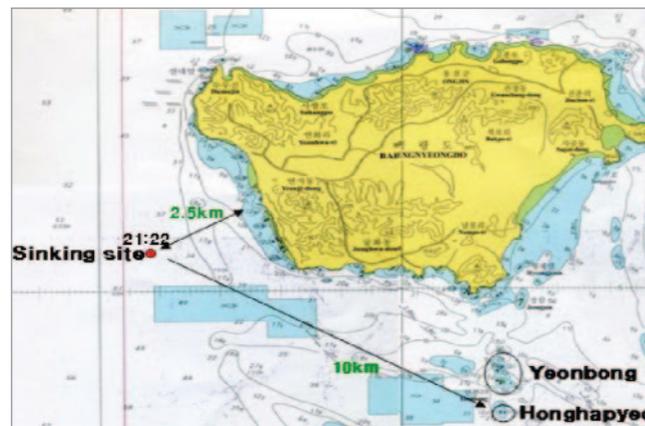
<Figure III-7-8> Reef(Honghapyeo) near Baekryong Island shown on a chart

The JIG visited relevant members of fishery group, government vessels, and fishers in Baekryong Island and checked whether there exist underwater obstacles in the vicinity of the sinking site but are not depicted on charts. Regarding the unknown sunken vessel, a fisher in Baekryong Island stated that he heard from his father that the vessel sunk sometime during Japanese colonial rule. Regarding the reef, Honghapyeo, reported by the Korean Broadcasting System(KBS) on March 30, 2010, is 10km southeast of the sinking site as shown in <Figure III-7-8>, and no unknown obstacles were found.

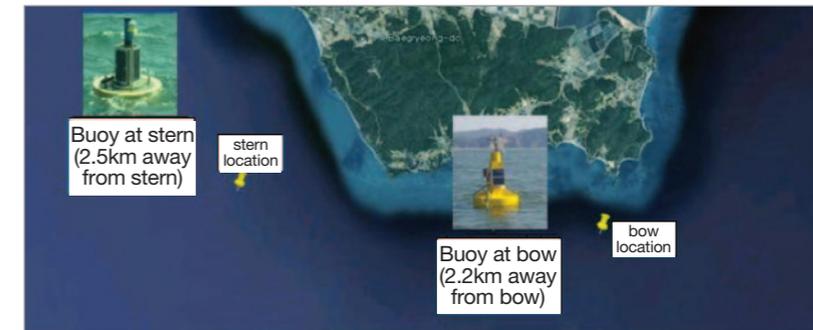
<Figure III-7-9> Locations of observation buoys of the NORI near Baekryong Island

Analysis on the tidal currents near Baekryong Island utilized 「Military Operational Tidal Movement and Tidal Currents Forecasting System」³⁶⁾ jointly developed by ROKN Maritime Tactical Intelligence Group and NORI. NORI verified the forecasting system with actual measurement data from 2 meteorological observation buoys installed in the sinking site to support the search and rescue operation since the sinking of ROKS Cheonan.

The comparison between 「Military operational tidal movement and tidal current forecasting system」 and the actual current speed measurement of data of buoys confirmed that the first one serves as a credible numeric model.

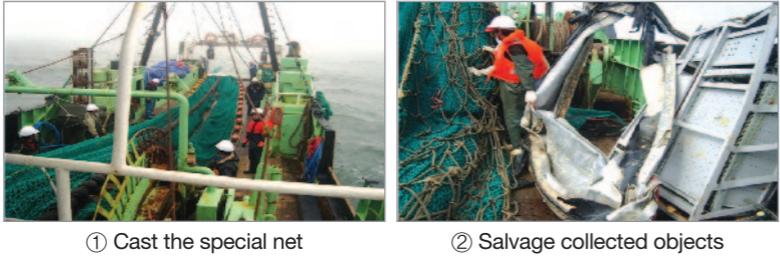
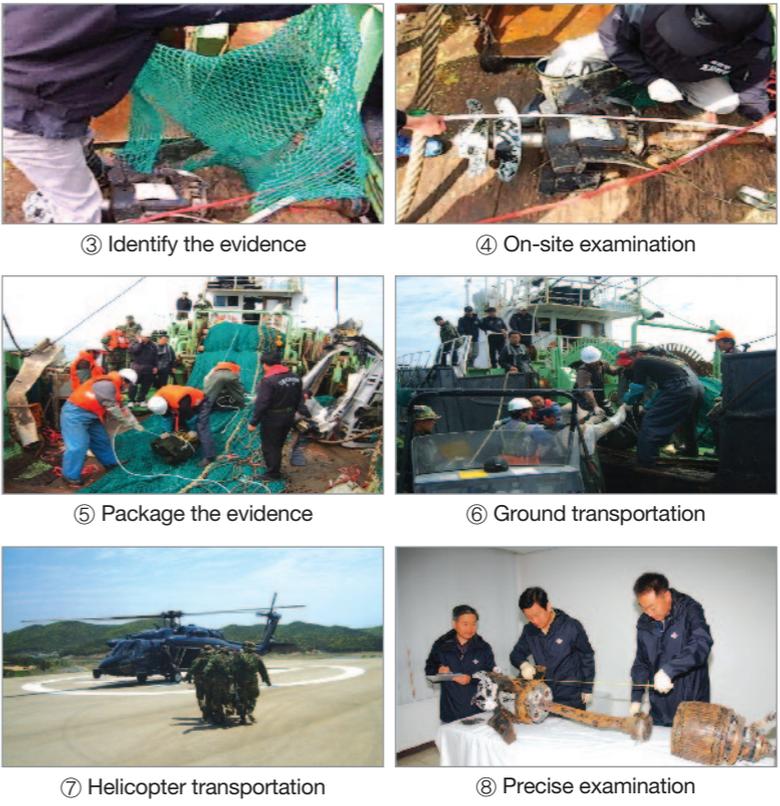
① Cast the special net ② Salvage collected objects

<Figure III-8-3> Recovery and collection of the evidence

The recovery and evidence selection procedure of the torpedo propulsion device is shown in <Figure III-8-3>.
